**DOT/FAA/AR-96/5**

# **Evaluation of Large Class B Cargo Compartment's Fire Protection**

David Blake

June 1996

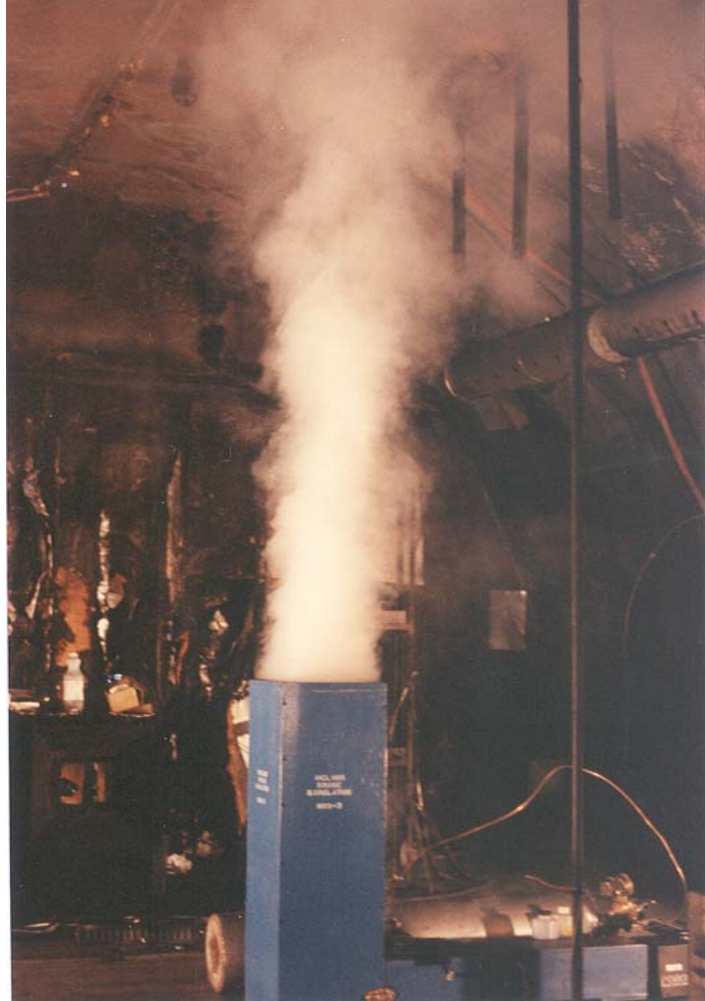
FIGURE 3. FEDERAL AVIATION ADMINISTRATION BUOYANT THEATRICAL SMOKE GENERATOR

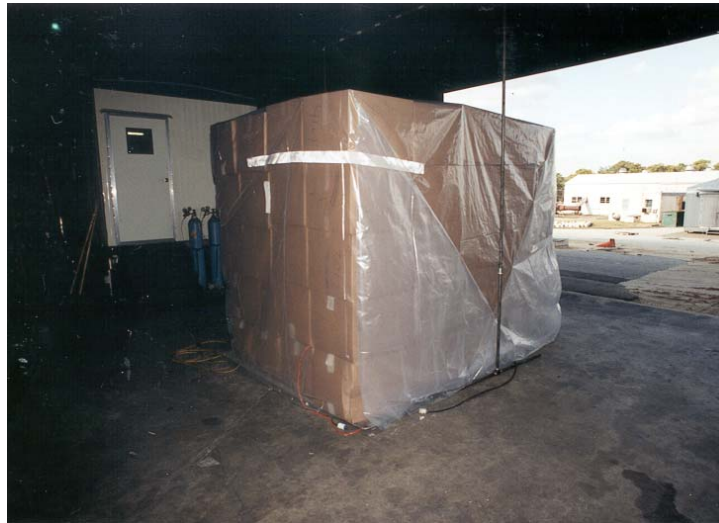
FIGURE 12. PALLET LOADED WITH HIGHER-DENSITY FIRE LOAD BEFORE IGNITION

**TEST 12.** This test was conducted on a 88- by 125-inch pallet on the floor of the Fire Test Facility. Cardboard boxes filled with computer tapes and various electronic components such as electric typewriters, computer terminals, etc., and packed in polystyrene was used as the fire load. The eight pounds per cubic foot average density of this fire load is representative of the industry average cargo density. The boxes were stacked on the pallet to a height of eight feet

and covered with a clear sheet of 6-mil polyethylene. One of the lower outside boxes of the stack was filled with shredded newspaper and a nichrome wire ignitor. The fire burned through the polyethylene adjacent to the ignited box 40 seconds after ignition. By 1.5 minutes into the test, the pallet was fully involved with flames approximately five feet above the top of the stacked boxes. The test was terminated at 3.5 minutes with more than 50 percent of the boxes consumed by the fire. Figure 12 shows the loaded pallet and figure 13 shows the fire approximately 1.5 minutes after ignition. This test demonstrated that the standard fire load employed by Federal Aviation Administration (FAA), consisting of shredded paper in cardboard boxes at a density of 2.5 pounds per cubic foot, is no worse a fire load (more severe fire condition) than the representative cargo load employed during this test.

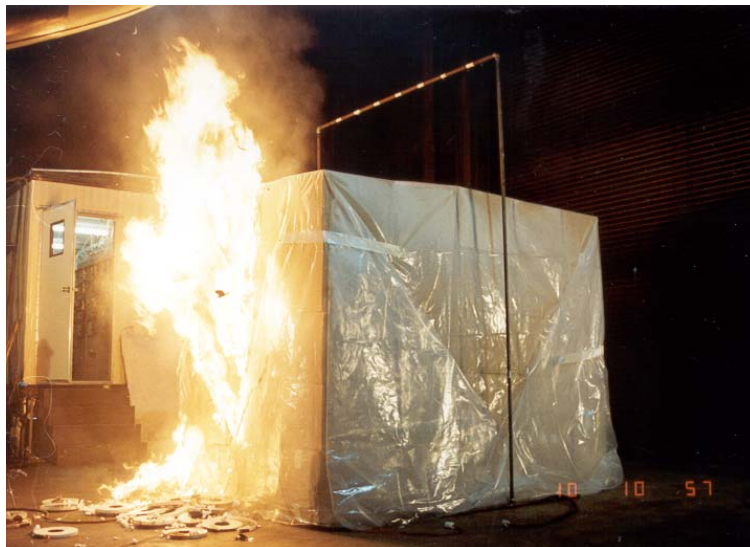
FIGURE 13. BURNING BOXES APPROXIMATELY 1.5 MINUTES AFTER IGNITION

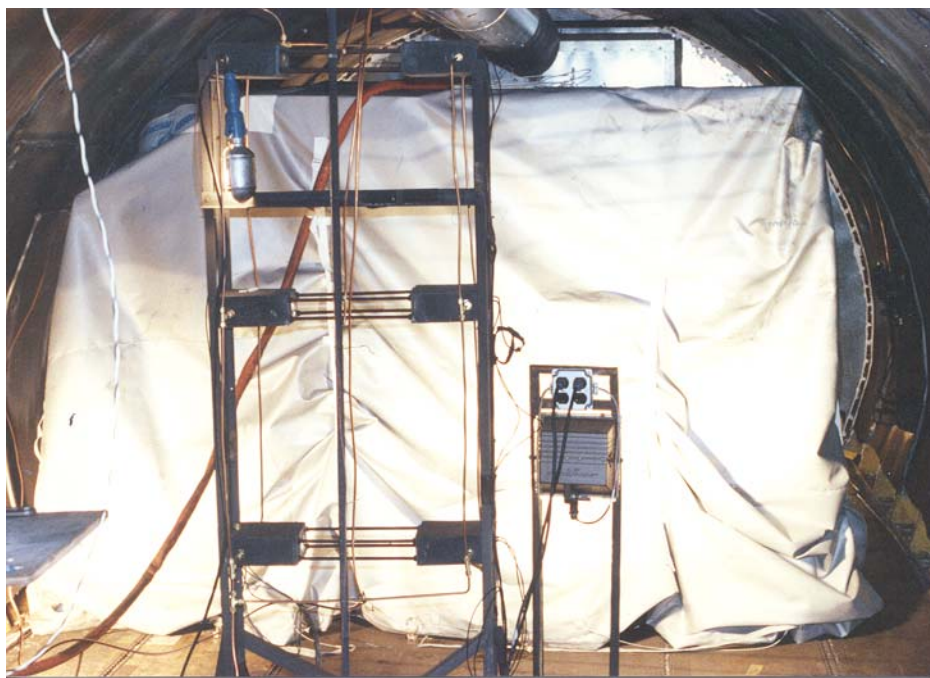
FIGURE 14. PALLET OF CARDBOARD BOXES COVERED WITH FCC

One of the options for increased fire protection in Class B compartments is through the use of Fire Containment Covers (FCC'S). These are flexible, fire resistant covers sized to fit over pallets and containers. The covers used in this project were supplied by a number of manufacturers and were constructed of coated, woven fiberglass cloth and coated, woven Kevlar cloth. The woven fiberglass-based covers will pass the oil burner test (FAR Part 25, Appendix F, Part III) required for cargo compartment liners but the Kevlar-based materials will not. The oil burner test exposes the materials to much higher temperatures than the full-scale tests but only for a five-minute duration. Thirteen tests were conducted using these FCC's with the test variables including ignition location, volatiles added to the fire load, and simulated in-service damage to the FCC's. The tests using FCC's were test number 1 through 6, 9, 11, and 22 through 26.

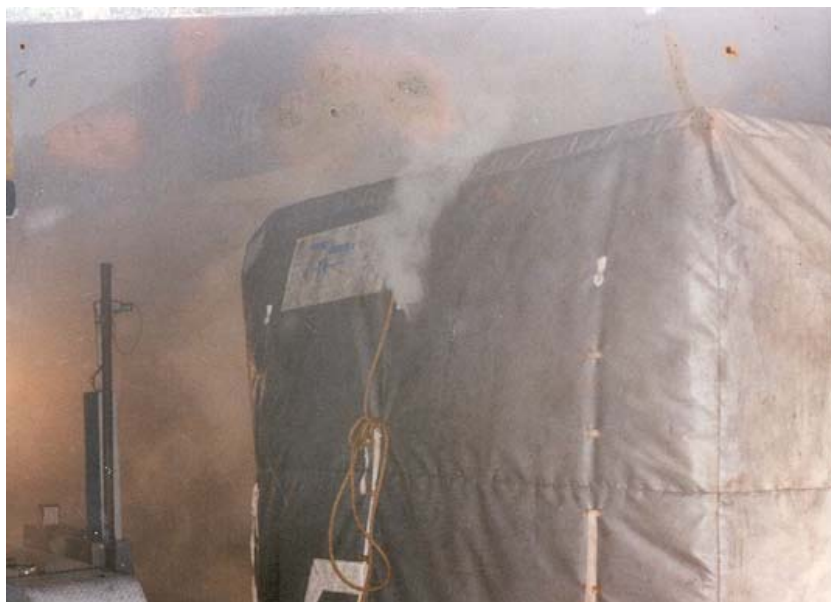
FIGURE 15. SMOKE ESCAPING FROM SLITS IN FCC

Test 11. In test 11, another new FCC of the same construction was used but was deliberately damaged in an attempt to simulate possible in service damage. Three “L” shaped slits, with each leg of the “L” approximately four inches long, were cut into three sides of the FCC at a height of five feet above the floor. The ignition location was the same as test 9. The fire again smoldered for the three-hour test but was contained within the FCC. The slits led to a chimney effect with heavy smoke exiting the slits and higher temperatures under the FCC than in test 9. Figure 15 shows the smoke escaping from the slits during this test.

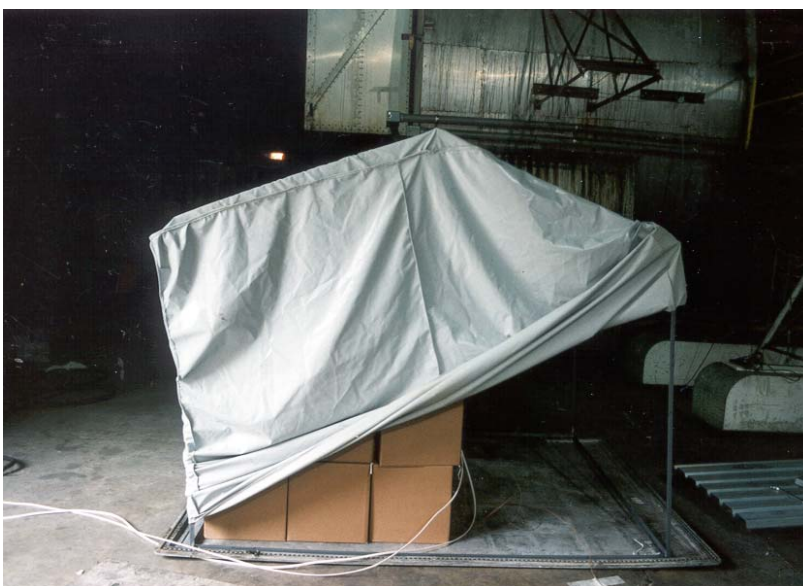
FIGURE 16. PARTIALLY LOADED PALLET COVERED WITH FCC

Test 26. Test 26 was a test of a slightly different concept than the previous FCC tests. There was a suggestion to attach a FCC to the walls and ceiling of an existing Class B cargo compartment as a somewhat permanent part of the aircraft. This concept was envisioned to be used on Class B compartments on smaller commuter airplanes where the volume of the compartment cannot be varied. A angle iron framework was constructed over which a silicone coated Kevlar based FCC was draped. The volume under the cover was approximately 425 cubic feet. Previous testing with this material showed that it could contain fires in fully loaded pallets. The purpose of this test was to determine if it could contain a fire in a partially loaded compartment with more oxygen available initially. Therefore slightly less than half of the 425 cubic feet was filled with cardboard boxes filled with shredded newspaper. The fire was ignited in a box on the top row. The test duration was one hour and the fire was contained. Figure 16 shows the partially loaded pallet before the cover was fully lowered.

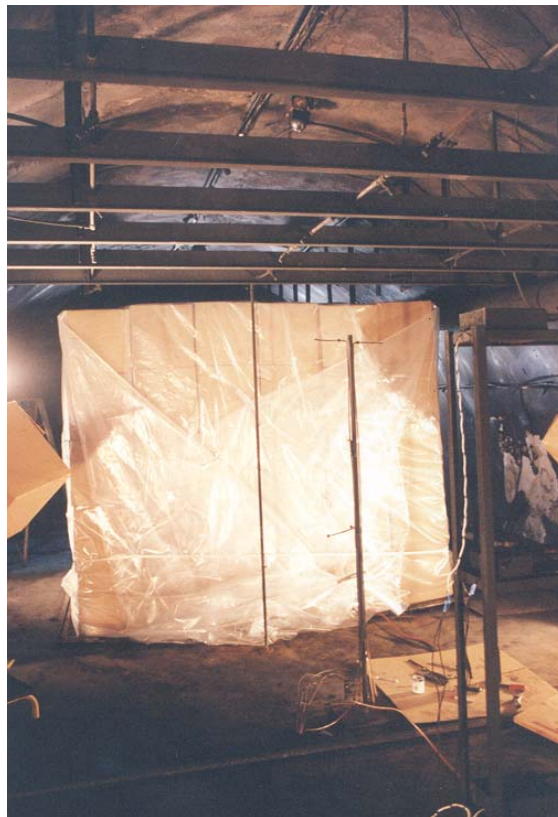
FIGURE 18. POLYETHYLENE COVERED BOXES ON PALLET

An active method for increased fire protection in Class B cargo compartments is a total-flood suppression system. Four tests (13, 14, 15, and 16) were conducted to determine the effectiveness of a Halon 1301 system in the 9000 cubic foot DC10 cargo compartment. The fire load for these tests was cardboard boxes filled with shredded newspaper, stacked eight feet high on a 125- by 88-inch aluminum pallet. The boxes were then covered with a sheet of clear, 6-mil polyethylene. Figure 18 shows the loaded pallet before the start of the test. For test 16, additional boxes covered with polyethylene were stacked around the pallet to simulate the adjacent pallets that would be present in a fully loaded compartment. A coil of nichrome wire inside one of the boxes was again used as the ignition source. The test variables were ignition location and the delay time between smoke detection and suppression system activation. The test procedure was to energize the nichrome wire, wait for smoke detection, shut off the ventilation system and discharge the initial Halon bottle after a predetermined delay, start the metered Halon system seven minutes after the initial discharge, run the metered system for 30 minutes, and then terminate the test. The test durations varied considerably because they were dependent on the initial smoke detector activation times.
